UNITED STATES ENVIRONMENTAL PROTECTION AGENCY  
REGION 4  
ATLANTA FEDERAL CENTER  
61 FORSYTH STREET  
ATLANTA, GEORGIA 30303-8960

SUBJ: Opportunity to Show Cause  
Resource Conservation and Recovery Act (RCRA) Compliance Evaluation Inspection (CEI)  
Ascend Performance Materials LLC  
EPA ID Number: ALD006320774

**COMPLIANCE EVALUATION INSPECTION PHOTOGRAPHS**

**OCTOBER 18-19, 2016**

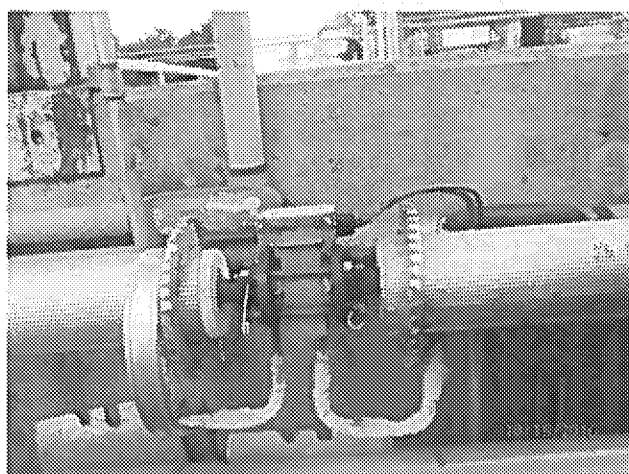
missing (Pictures 7-11, 12-14). A flow meter was noted with the insulation removed and without Subpart BB tag (Picture 5). When the inspectors asked Mr. Burke about this, he stated that the connection did not require marking with a tag because it was normally covered in insulation. The inspectors also noted that leak detection and repair (LDAR) tags for tank pumps were located on the electrical piping instead of the tank piping (Picture 11).

Picture 5 - PN Waste to Railcar piping with uninsulated flowmeter – no BB tag

Pursuant to ADEM Admin. Code r. 335-14-3-.03(5)(a)1.(ii) [40 C.F.R. § 262.34(a)(1)(ii)], which incorporates ADEM Admin. Code r. 335-14-6-.28 [40 C.F.R. Part 265, Subpart BB], and is a condition of the LQG Permit Exemption, a facility that manages hazardous waste with an organic concentrations of at least 10% by weight, in equipment, such as valves, pumps, compressors, pressure relief devices, sampling connection systems, open-ended valves or lines, flanges, and any control devices or systems, must comply with the RCRA Subpart BB Organic Air Emission Standards for Equipment Leaks, including, but not limited to, the recordkeeping requirements of ADEM Admin. Code r. 335-14-6-.28(15) [40 C.F.R. 265.1064].

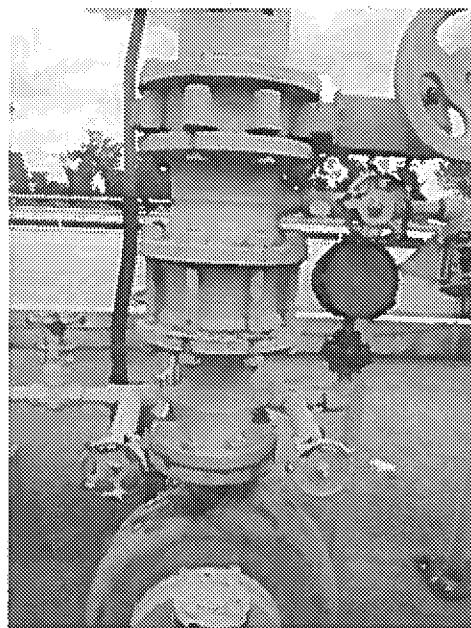
The inspectors walked the PN Waste piping located outside and inside the secondary containment area (Pictures 3-14, 19). At the time of the inspection, the inspectors observed the tank piping was not consistently marked on each piece of equipment or the tag wire was in place but the tag was

Picture 6 - PN Waste to Railcar piping with missing BB tags

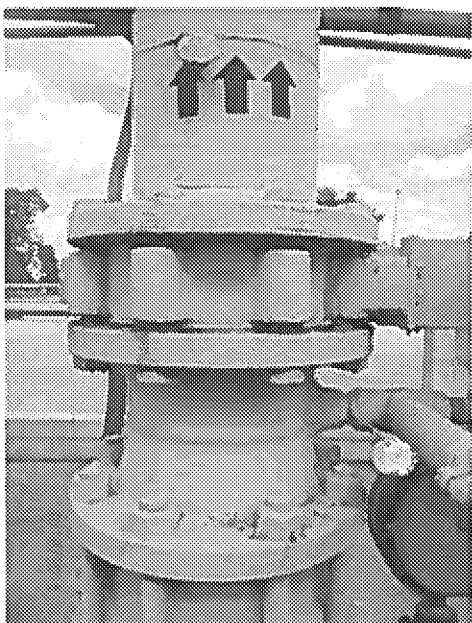
Picture 7 - PN Waste to Railcar piping with BB tag covering several connections

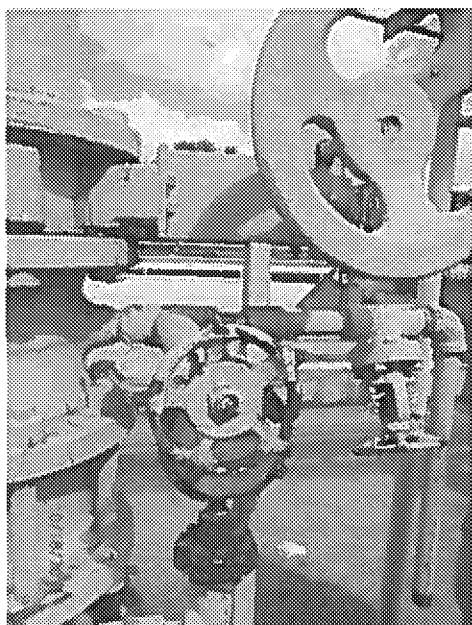
Picture 8 - PN Waste to Railcar piping with BB tag covering several connections

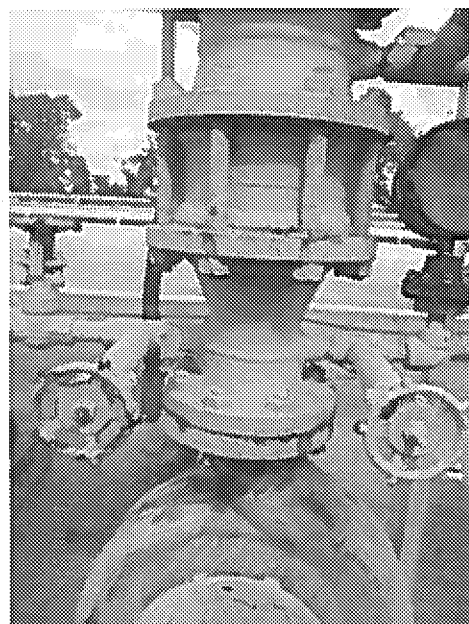
Picture 9 - PN Waste to Railcar piping with BB tag covering several connections

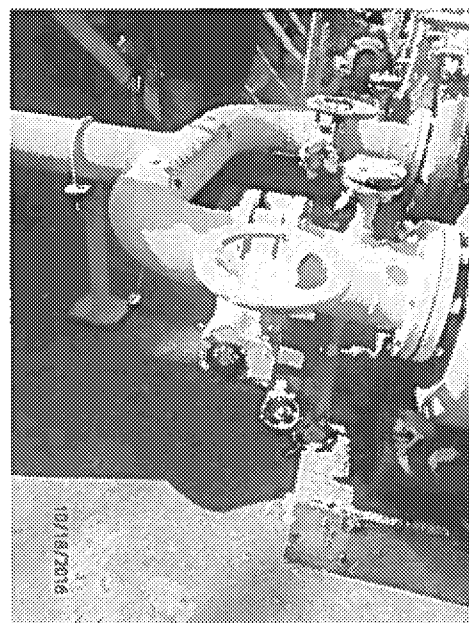
Picture 10 - PN Waste to Railcar piping with BB tag covering several connections

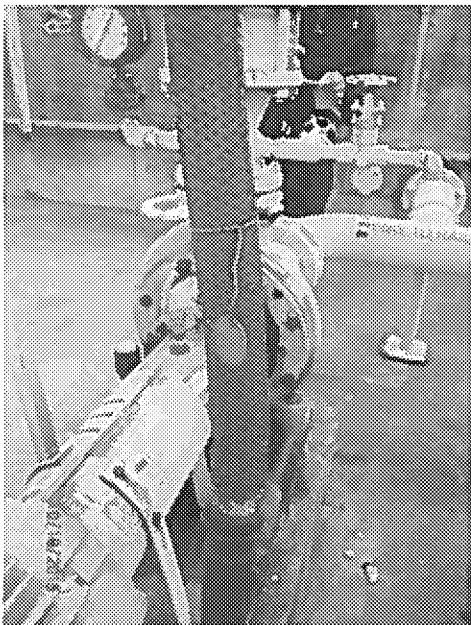
Picture 11 - PN Waste to Railcar pump BB tag on an electrical conduit

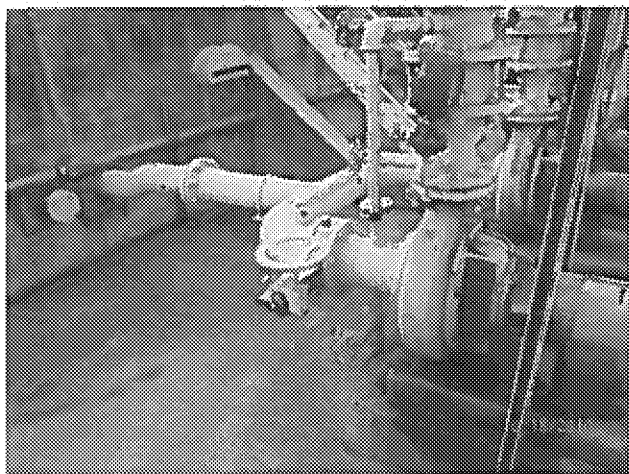
Picture 12 - PN Waste to Railcar piping with BB tag covering several connections

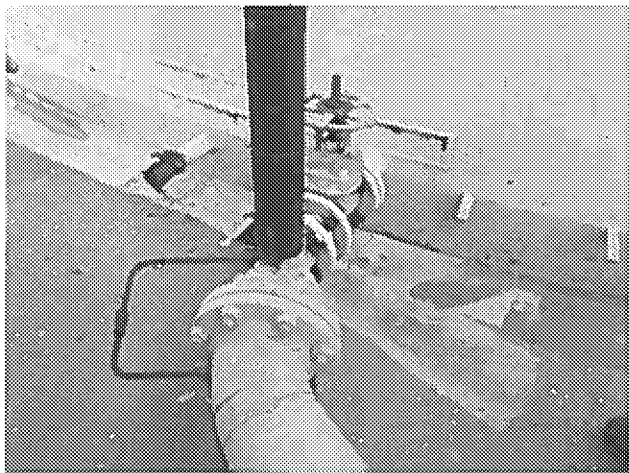
Picture 13 - PN Waste to Railcar piping with BB tag covering several connections

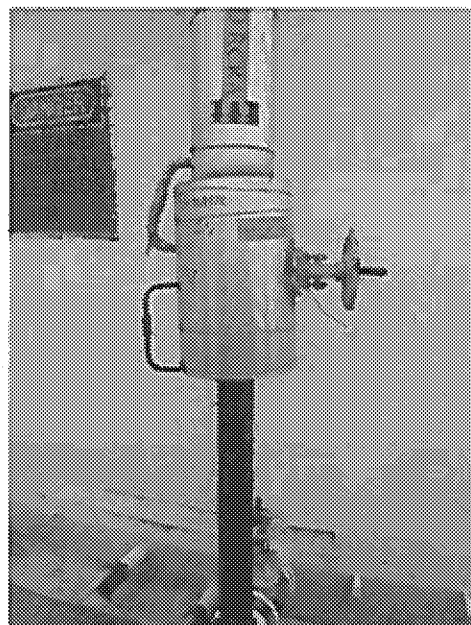
Picture 14 - PN Waste to RCRA piping with BB tag covering several connections

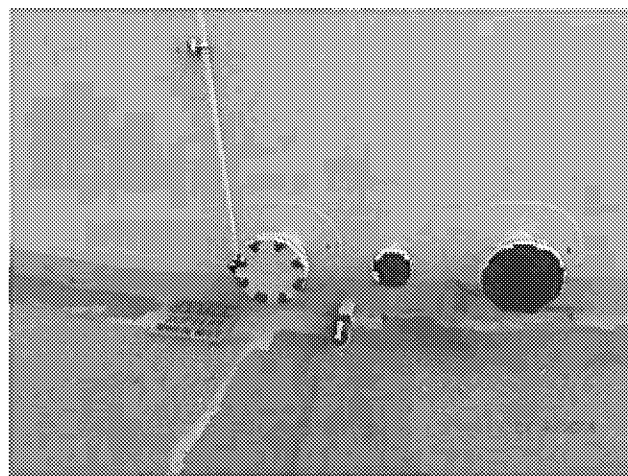
The inspectors observed that the bottom of the hazardous waste tank had 18 ports open to the secondary containment area (Picture 15). Mr. Burke explained there was an additional secondary containment area inside the tank and it captured any leaks from the tank and released them to the secondary containment area surrounding the tank. No releases from the ports were observed at the time of the inspection. The inspectors also noted that the open ports were not marked or tagged for LDAR. The secondary containment floor had minor chipping in random locations, but otherwise appeared to be intact and sealed.

Picture 15 - PN waste tank leak ports

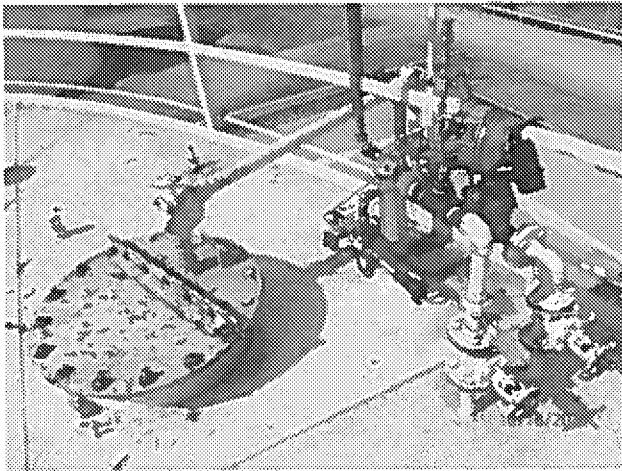
Mr. Parvez Mallick, EPA inspector, accompanied Ms. Jenkins to the top of tank and observed the piping (Pictures 16-17). Tags were noted on the manhole cover and two connectors only.

Picture 16 - PN waste tank top piping

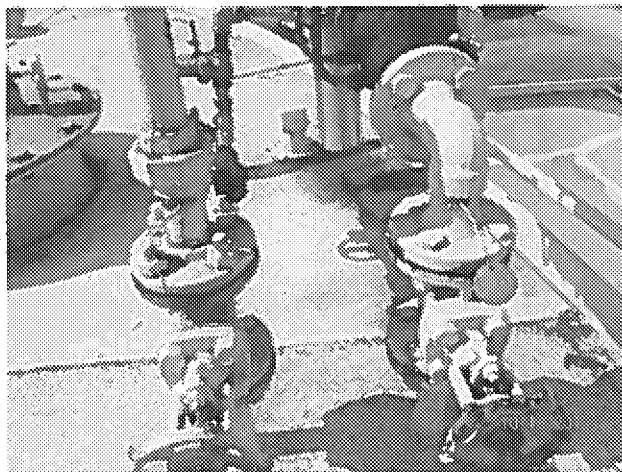
Picture 17 - PN waste tank top piping

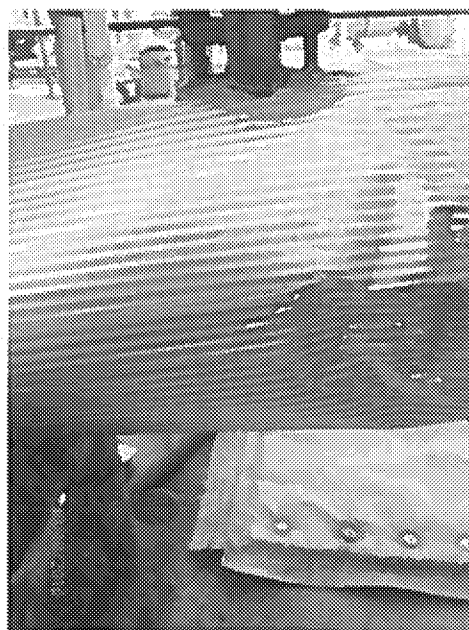
The inspectors followed the hazardous waste piping back to the point of generation, which is the PN refiner tails column (Pictures 21-34). At the time of the inspection, the area was closed for maintenance, but the inspectors were allowed to examine the hazardous waste piping and connections. A LDAR tag was tucked into the insulation around one valve (Picture 25, 27-29), and a valve directly overhead did not have a LDAR tag at all (Picture 26).

Picture 24 - PN Refiner Tails with BB tag tucked inside the insulation

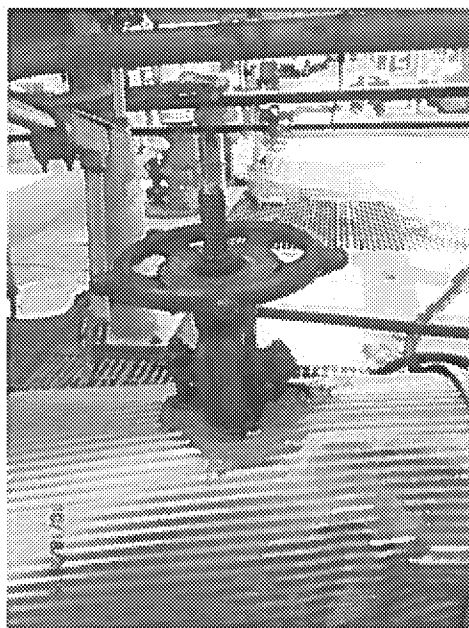
Picture 25 - PN Refiner Tails with BB tag tucked inside the insulation

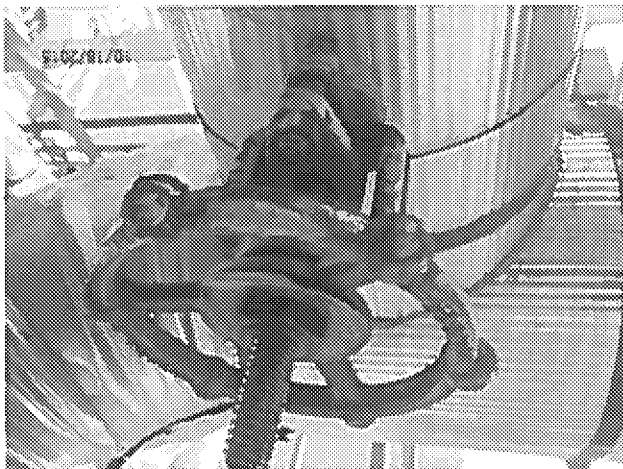
Picture 26 - PN Refiner Tails valve missing BB tag

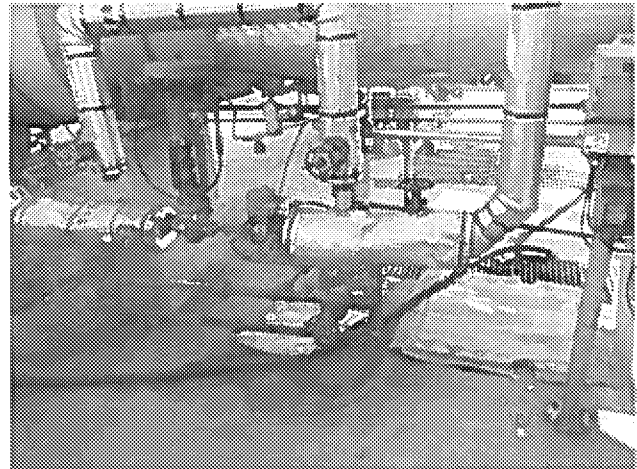
Picture 29 - PN Refiner Tails piping missing BB tags

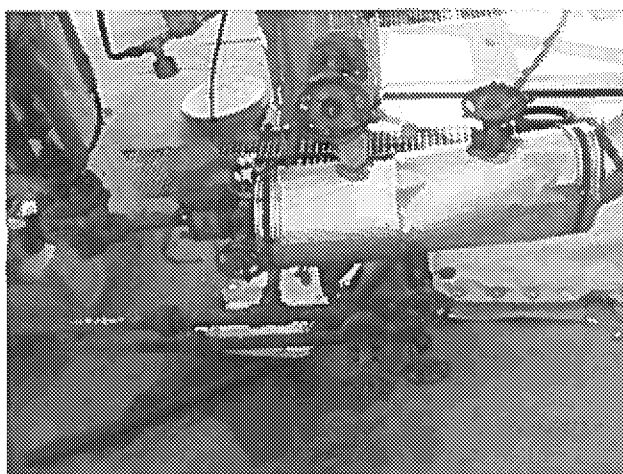
Picture 27 - PN Refiner Tails piping missing BB tags

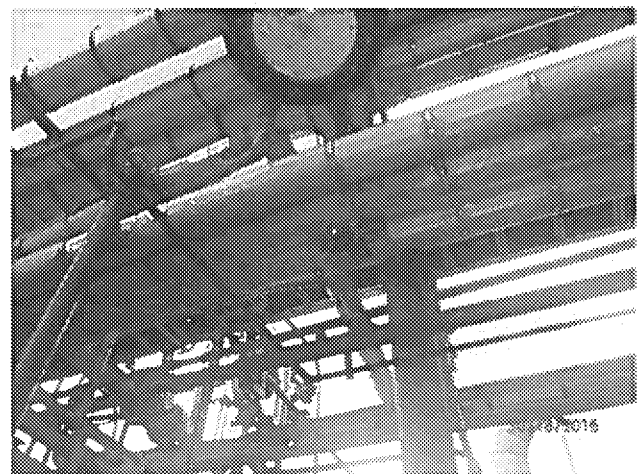
The PN refiner tails piping further overhead (Pictures 31-32) had the insulation removed from around the flanges, exposing the connection and revealed the missing LDAR tag (Picture 30). Hazardous waste piping with the faded lettering "PN Tails to RCRA" had the insulation removed for maintenance. The flange connecting the piping did not have a LDAR tag attached.

Picture 30 - PN Refiner Tails piping missing BB tags

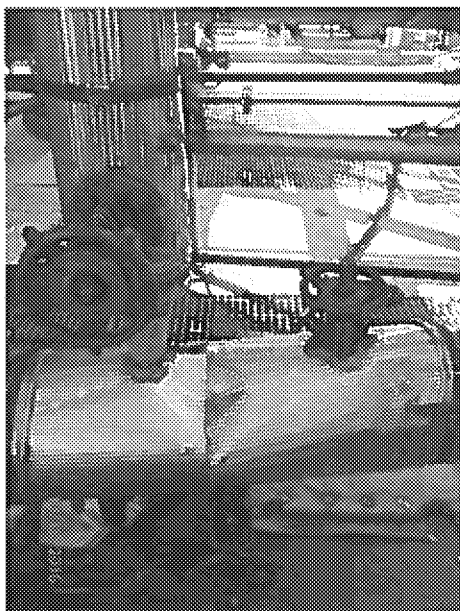
Picture 28 - PN Refiner Tails piping missing BB tags

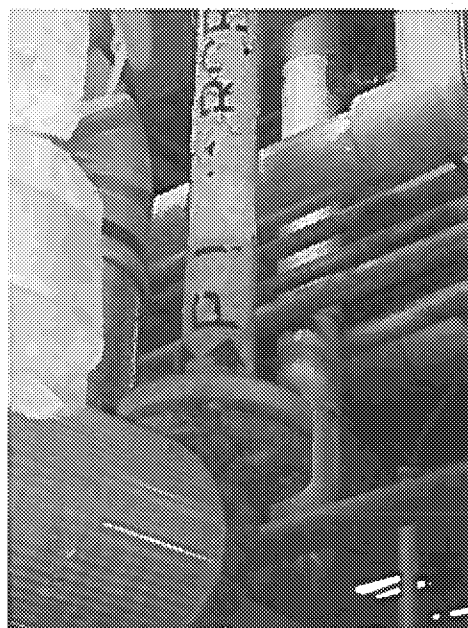
Picture 34 - PN Refiner Tails uninsulated piping labeled and missing BB tags

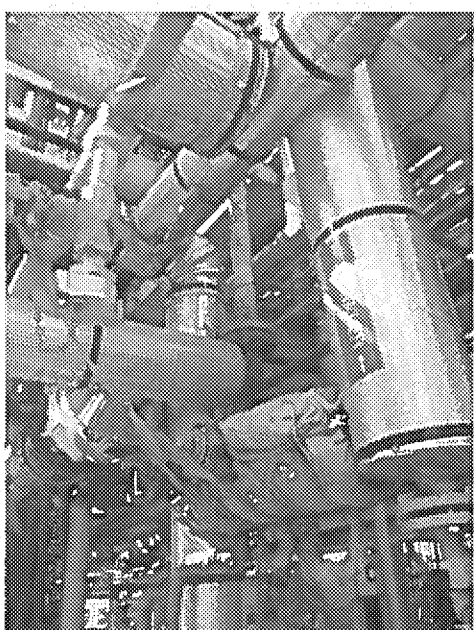
Picture 33 - PN Refiner Tails uninsulated piping labeled and missing BB tags

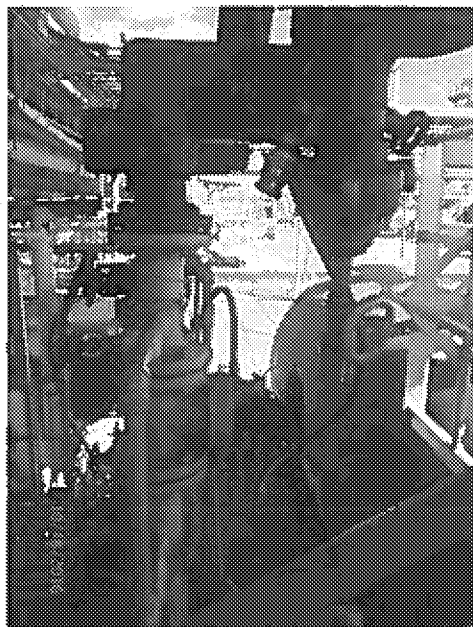
Picture 43 - Railcar unloading piping missing BB tags at flanges and valves

**Pursuant to ADEM Admin. Code r. 335-14-3-.03(5)(a)1.(ii) [40 C.F.R. § 262.34(a)(1)(ii)], which incorporates ADEM Admin. Code r. 335-14-6-.28 [40 C.F.R. Part 265, Subpart BB], and is a condition of the LQG Permit Exemption, a facility that manages hazardous waste with an organic concentrations of at least 10% by weight, in equipment, such as valves, pumps, compressors, pressure relief devices, sampling connection systems, open-ended valves or lines, flanges, and any control devices or systems, must comply with the RCRA Subpart BB Organic Air Emission Standards for Equipment Leaks, including, but not limited to, the recordkeeping requirements of ADEM Admin. Code r. 335-14-6-.28(15) [40 C.F.R. § 265.1064].**

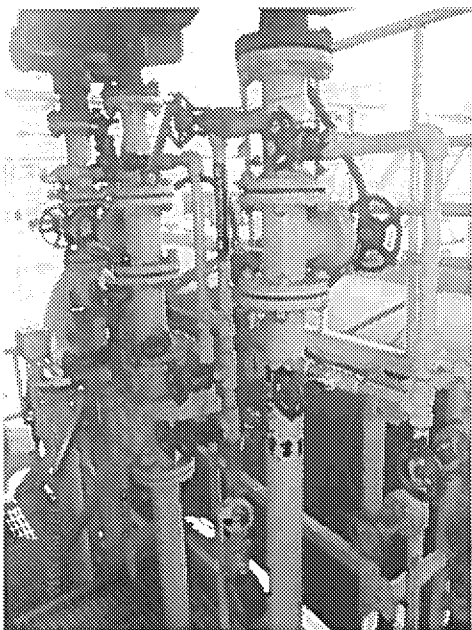
The inspectors observed the hazardous waste piping that was directly connected to the railcar (Pictures 41-46), which was labeled "PNW" and marked with LDAR tags. However, some of the flanges and valves (Pictures 42, 44), and the connection hose (Pictures 45-46) were not marked with LDAR tags.

Picture 42 - Railcar unloading piping

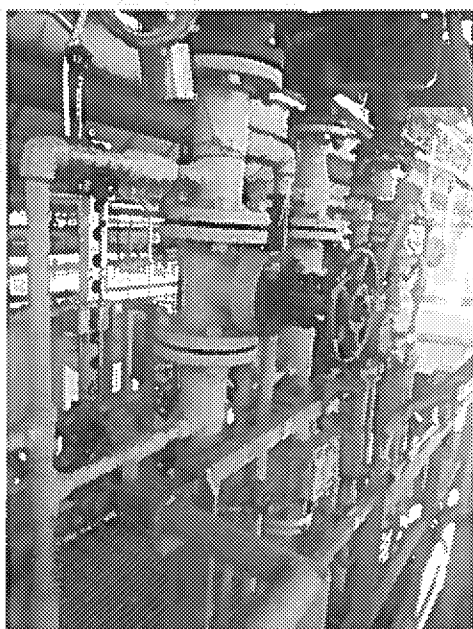
Picture 44 - Railcar unloading piping missing BB tags at flanges and valves

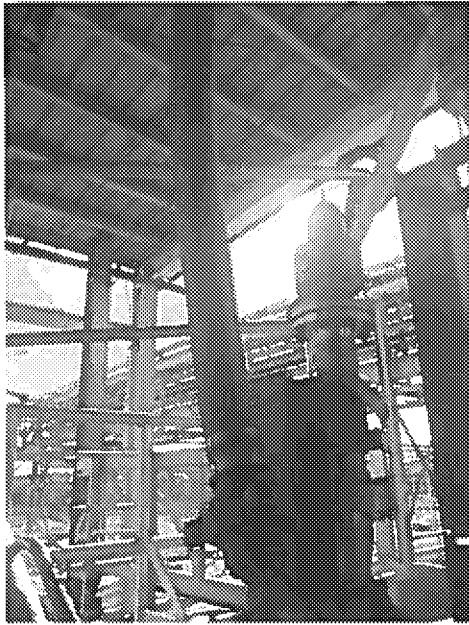
Picture 45 - Railcar unloading hose

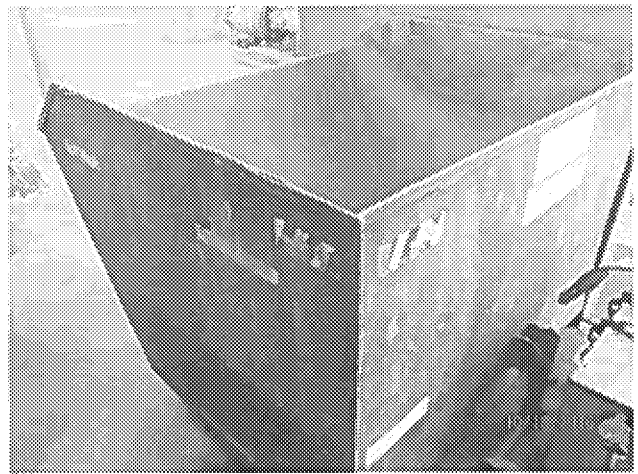
At the time of the inspection, the hopper was empty but was not marked "Hazardous Waste" or with the contents of the hopper to indicate its specific use (Pictures 57-58). The Ascend personnel labeled the hopper during the inspection.

Picture 57 -- Cadmium sludge hopper - unlabeled

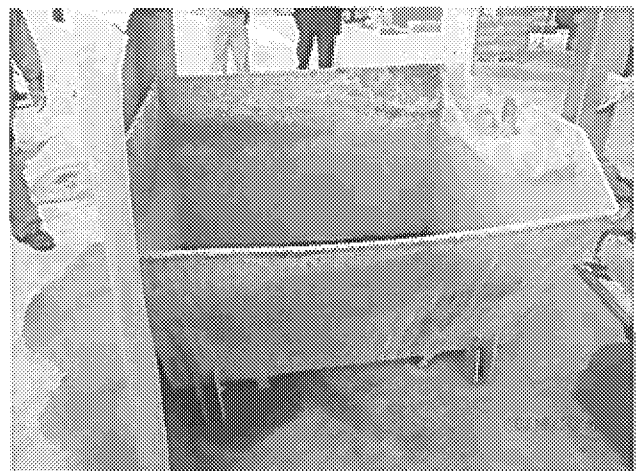
Picture 58 - Cadmium sludge hopper - unlabeled

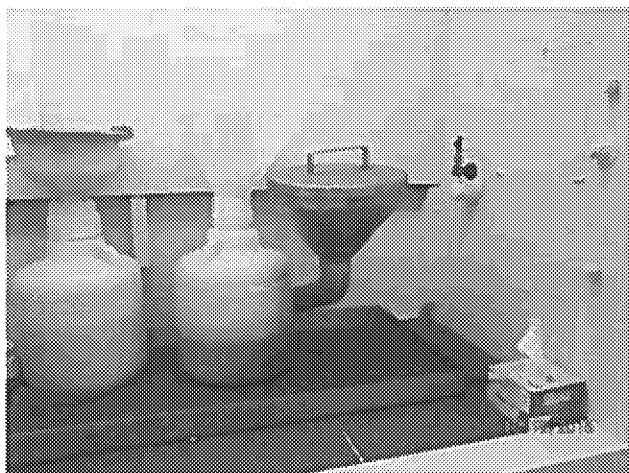
Inside the lab, the Lab Manager, Mrs. Luciana Vergara and the Instrument Repair and Solution Prep Technician, Mr. Darrell Eddleman, escorted the inspectors around the lab and to the interior SAAs. The fume hood for the extraction waste contained a funneled vacuum system and containers of production materials to be returned to process. The inspectors observed that the funnel used to convey the lab extraction waste, a hazardous waste, to the exterior SAA drum, was not labeled "Hazardous Waste" or with the contents of what was being conveyed (Picture 60).

Picture 60 – Lab fume hood extraction waste vacuum funnel

**Pursuant to ADEM Admin. Code r. 335-14-3-.03(5)(c)1.(ii) [40 C.F.R. § 262.34(c)(1)(ii)], which is a condition of the SAA Permit Exemption, a generator is required to mark satellite accumulation containers either with the words "Hazardous Waste" or with other words that identify the contents of the containers.**

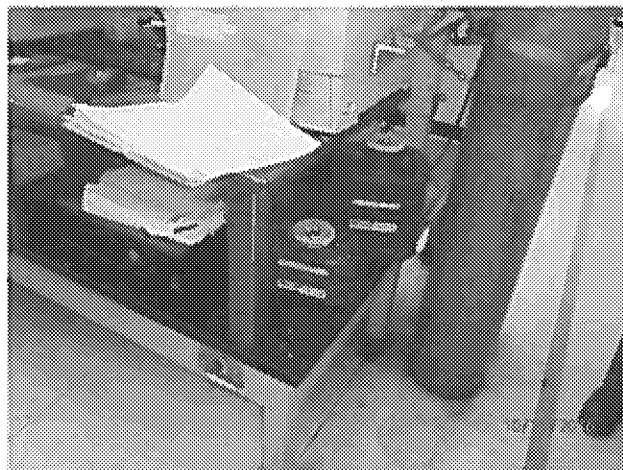
During the lab walk through the inspectors observed two 5-gallon containers for the collection of the used GC vials (Pictures 61-62), a black 55-gallon drum of used syringes and needles in the chemical storage room (Picture 63) and eleven used sharps containers ranging in size from 3.3 quarts to 6.9 quarts (Picture 64). All of these wastes were hazardous wastes. The inspectors observed the drums to be labeled as hazardous waste, but the sharps containers were not labeled. The Ascend personnel explained that the used sharps containers were emptied into the sharps drum because the materials handled in the lab were considered hazardous waste. The inspectors stated that the used sharps containers should be labeled as hazardous waste. In addition, the containers were not consistently kept closed. The Ascend personnel proposed to use the larger container to collect the used sharps in the future.

Picture 64 – Lab small open sharps containers

**Pursuant to ADEM Admin. Code r. 335-14-3-.03(5)(c)1.(i) [40 C.F.R. § 262.34(c)(1)(i)], which incorporates ADEM Admin. Code r. 335-14-6-.09(4)(a) [40 C.F.R. § 265.173(a)], and is a condition of the SAA Permit Exemption, a generator is required to keep containers of hazardous waste closed when waste is not being added or removed.**

**Pursuant to ADEM Admin. Code r. 335-14-3-.03(5)(c)1.(ii) [40 C.F.R. § 262.34(c)(1)(ii)], which is a condition of the SAA Permit Exemption, a generator is required to mark satellite accumulation containers either with the words “Hazardous Waste” or with other words that identify the contents of the containers.**

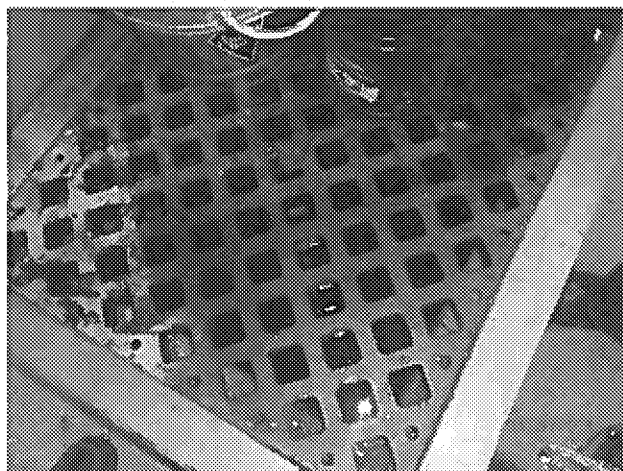
The inspectors toured the Central Maintenance Shop and observed a 55-gallon used oil drum on secondary containment pallet (Pictures 65-66). The inspectors observed that the inside of the pallet contained oil. When asked, the Ascend personnel stated the containment was cleaned out annually. The drum was observed labeled and closed.

Picture 65 – Central Maintenance Shop used oil secondary containment

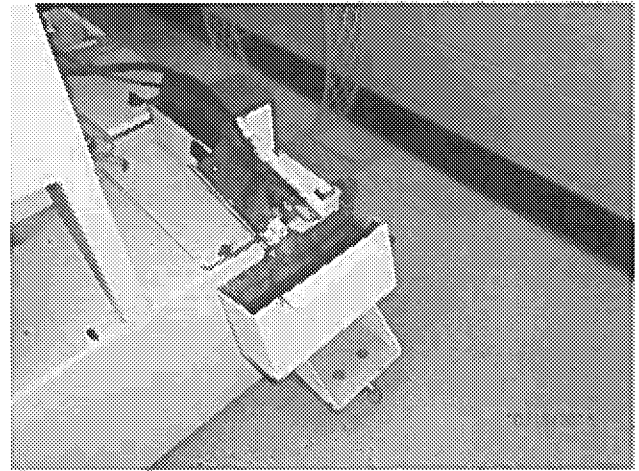
A non-hazardous waste parts washer (Picture 67) was observed near the back of the area. The unit was not running during the inspection, but Mr. Tim Looney, Pump Shop Mechanic, stated that the rinse water from the parts washer were pumped into drums and taken to the HWSA. On the side of the parts washer was an oil skimmer. The oil from the skimmer is discarded as used oil, but the skimmer was not labeled as “Used Oil” (Picture 68).

Picture 68 -- Central Maintenance Shop parts washer oil skimmer
